TD-05-032
10/05

EDDY CURRENT SCANNING REPORT

FNAL-3RDHARMONIC CAVITIES #3-6

FNAL/Technical Division

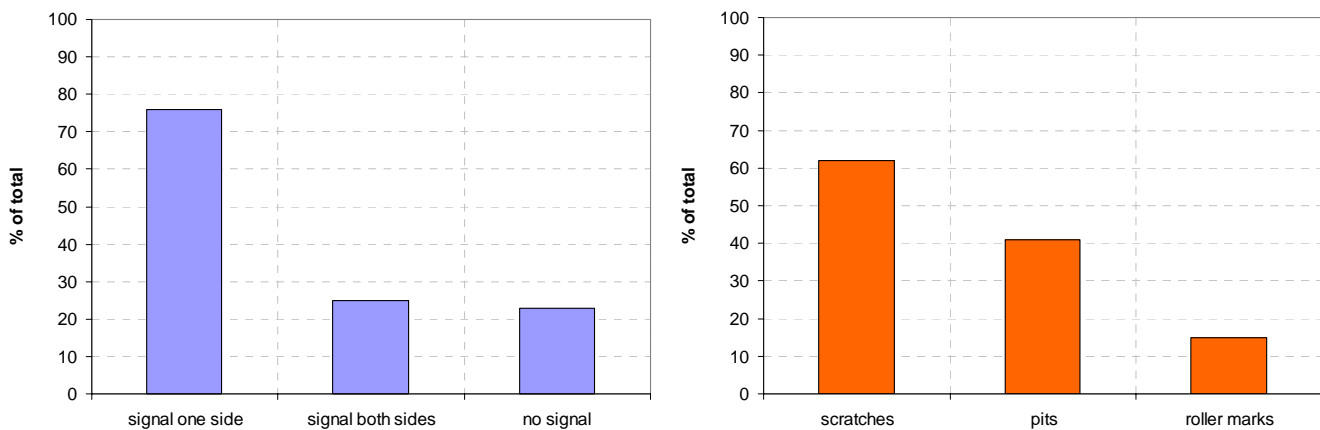
The above table can be summarized in the following way: From the 90 discs, 21 (23%) give no signal (**OK**) and 22 discs (25%) give signals on both sides (NO or **NO**). Therefore 69 discs (76%) have at least one side giving a signal. 74 sides (41%) have visible pits (of which only 25% appear in the eddy current scans), 112 sides (62%) have scratches, 27 sides (15%) have roller marks (which only appear in the eddy current scans).

Figure 3: Evaluation summary of 3rd harmonic cavity blanks based on eddy current scans and optical inspections. Left: Percent of discs with signals on one, both or no side. Right: Percent of sides with scratches, pits and “rollermarks”.

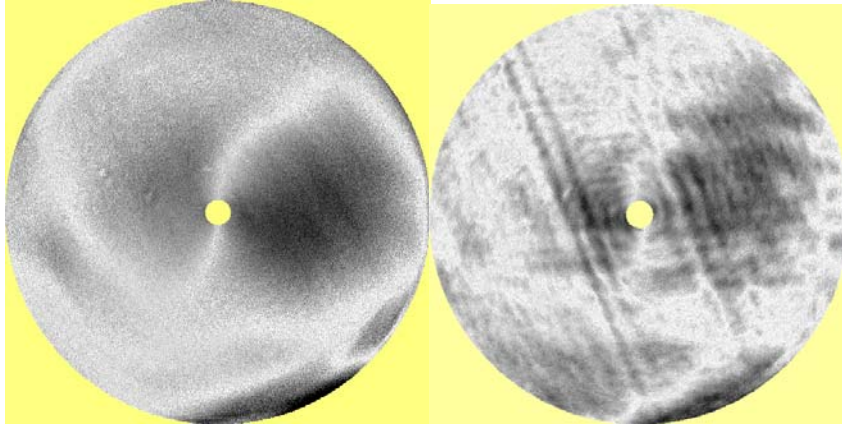
Figure 4 shows the results of eddy current scans performed with the SNS/FNAL scanner on disc 14 before and after removing 175 μm with BCP etching. The plots clearly show a change of appearance of the scan, possibly a result of the increase of surface roughness due to the BCP etching. Also, and this is corroborated by simple visual inspection, most defects are still present after etching. This result indicates that the defects found in some blanks from this batch will not be removed by the subsequent etching steps and that these particular disc-sides should not be used for the inside of the cavities.

Figure 4: Scan of disc 14/2 before (left) and after (right) 175 μm were removed with BCP etching.

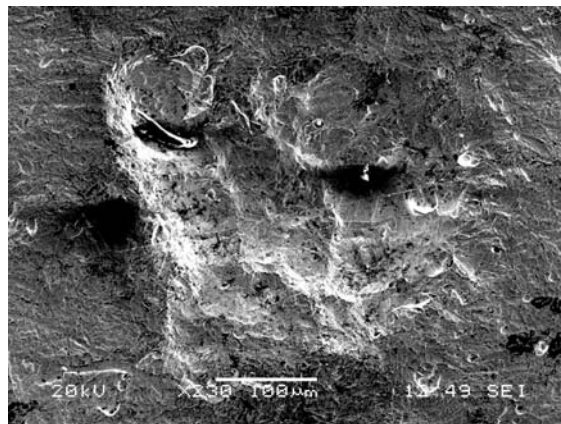
A chemical analysis with EDX of the first micron of the crater-lining surface in the pit of disc 134 (side 2) revealed no difference to the rest of the surface. Figure 5 shows an SEM image of this (shallow) pit.

Figure 5: SEM pic of surface pit in disc 134-side 2.
